# Website check

## Cedar Lantern: five-page fictional demonstration

Four browser findings with reproduction steps, screenshots and retest results. This is original synthetic work, not a real customer project, purchase or testimonial.

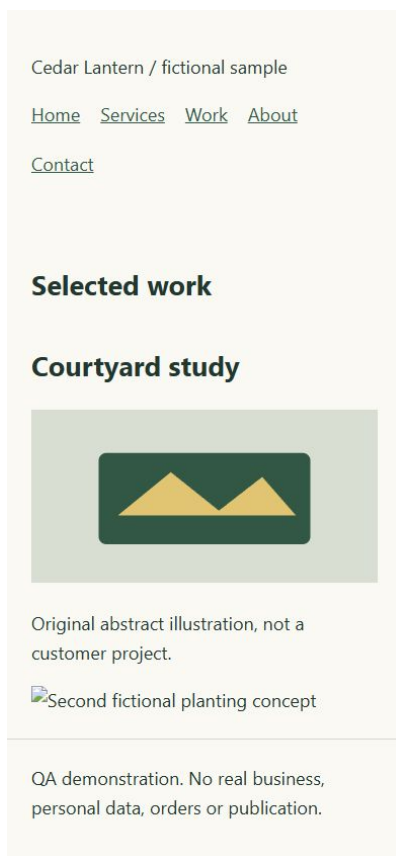
Open Work and inspect the second image area.

The original second image displays its fallback text and broken-image icon in the selected screenshots. Browser image complete=true but naturalWidth=0 and naturalHeight=0 at both widths. Its asset request returns 404.

Original: fallback text and broken image

## Recommended action

Restore the intended asset or correct its path. Require nonzero intrinsic dimensions and visibly inspect the resulting image.

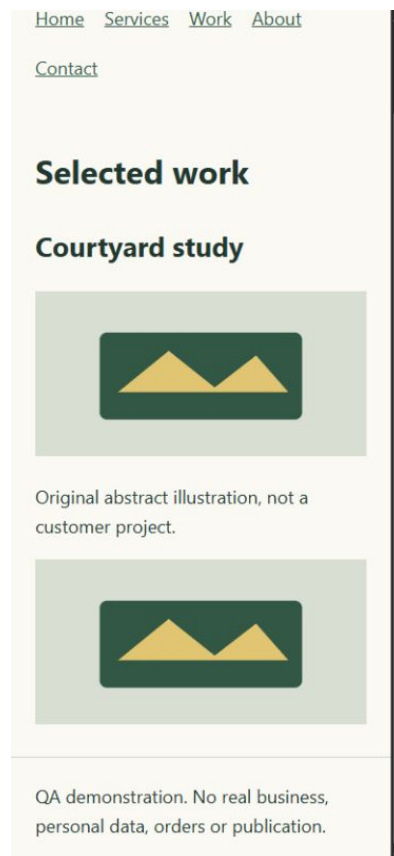
Both images in the repaired control have intrinsic size 720x360 at both widths; the lower narrow capture visibly shows the second image.

Repaired: second image visibly loaded; illustrative capture
